**Appendix A**  
**Shell Martinez Refinery**  
**EPA Inspection Photograph Log**

### Photograph Log

**Region 9 Enforcement Division  
75 Hawthorne Street  
San Francisco, CA 94105  
Shell Martinez Refinery Photographs  
(referenced in EPA's inspection report)**

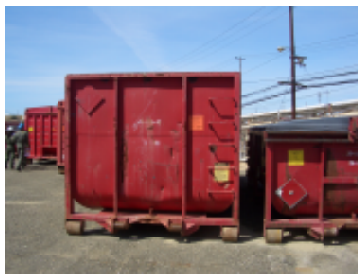
CIMG2378.JPG

CIMG2378	20 cubic yard roll-off bin located at Shell's Bin Storage Yard. The red container on the left was marked as "Designated Waste" and the container on the right was labeled as "Hazardous Waste". This area was treated as a less than 90 day hazardous waste accumulation area (HWAA).
CIMG2379	Close-up of the label shown in photo CIMG2378 in Shell's Bin Storage Yard HWAA.
CIMG2380	Close-up of the label shown in photo CIMG2378 in Shell's Bin Storage Yard HWAA.
CIMG2381	Close-up of a label on a roll-off container in Shell's Bin Storage Yard HWAA.
CIMG2382	Excluded recyclable material roll-off container in Shell's Bin Storage Yard HWAA.
CIMG2383	Overview of containers in Shell's Bin Storage Yard HWAA.
CIMG2384	Overview of containers in Shell's Bin Storage Yard HWAA.
CIMG2385	Overview of containers in Shell's Bin Storage Yard HWAA.
CIMG2386	Overview of containers in Shell's Bin Storage Yard HWAA.
CIMG2387	Overview of containers in Shell's Bin Storage Yard HWAA.

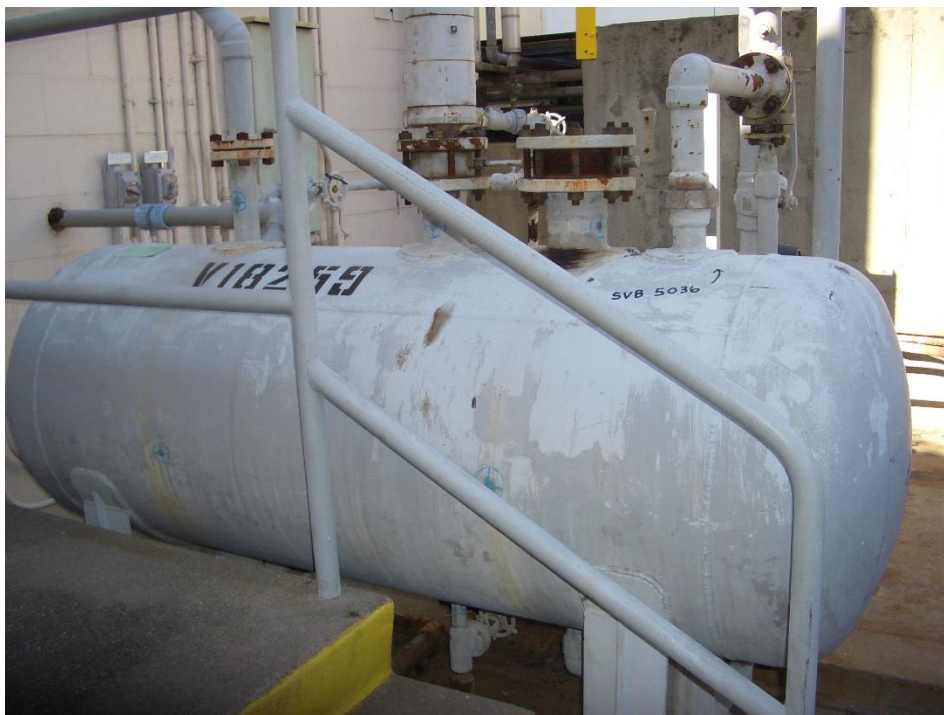
CIMG2529 – Laboratory tank, vessel V-18259, containing discarded spent solvents

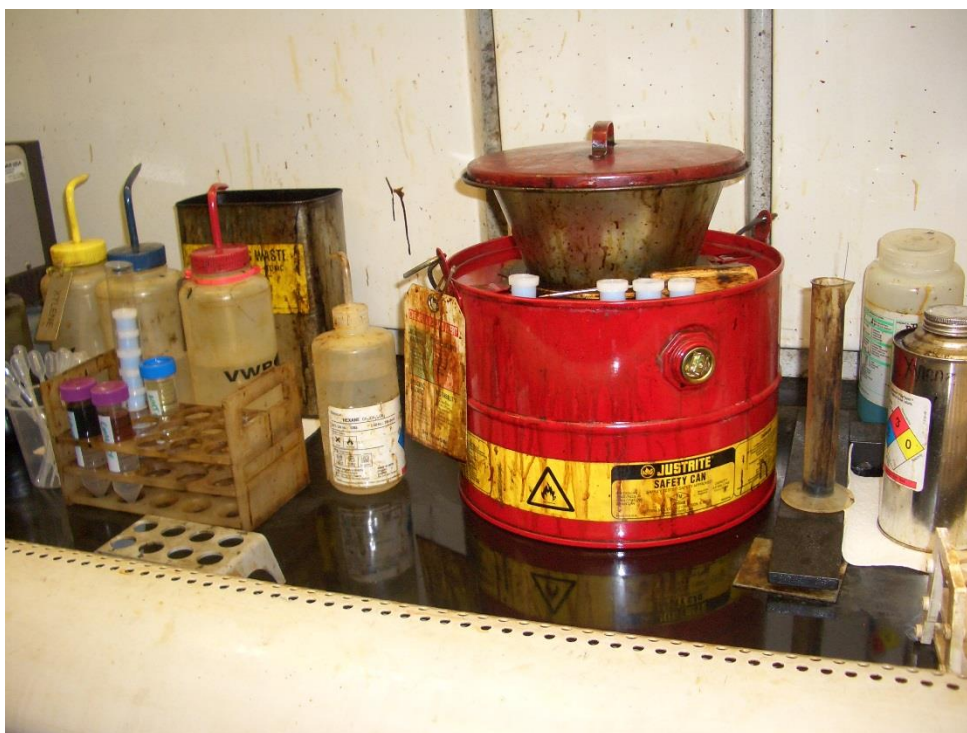
CIMG 2527 Fume hood 6A at SMR's Quality Assurance Laboratory. The spent solvents are placed in the one gallon red container pictured in the center of the photo. The container was not labeled.

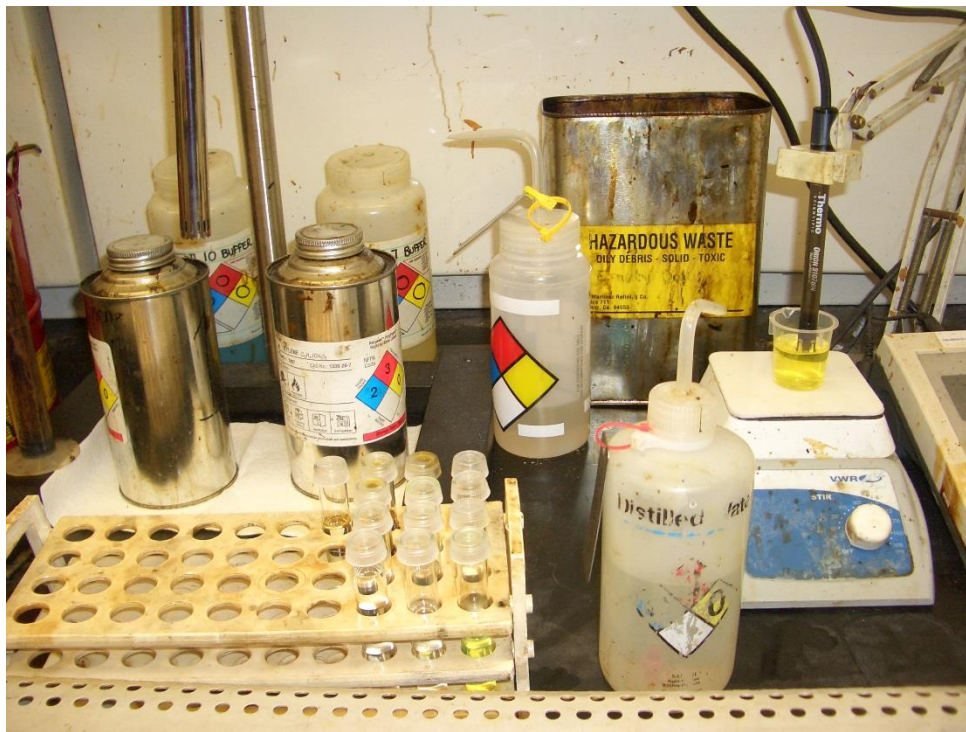
CIMG2528 Fume hood 6A at SMR's Quality Assurance Laboratory. Note the container that was used to collect waste was open.

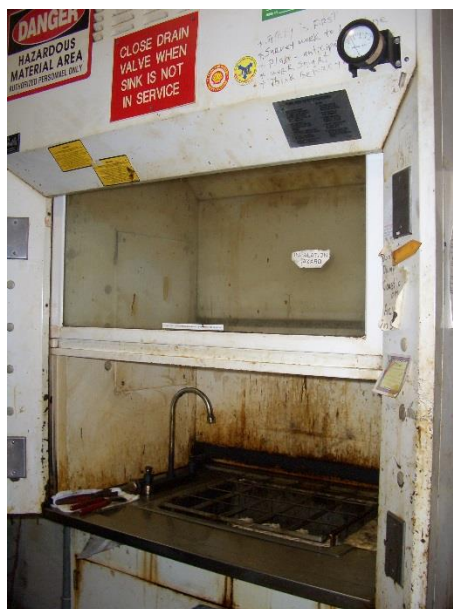
CIMG2530 Fume hood in the building adjacent to the main Quality Assurance Laboratory. The spent solvents collected in the containers in the fume hoods in the laboratory were brought here to be poured down the sink to Vessel V-18259.

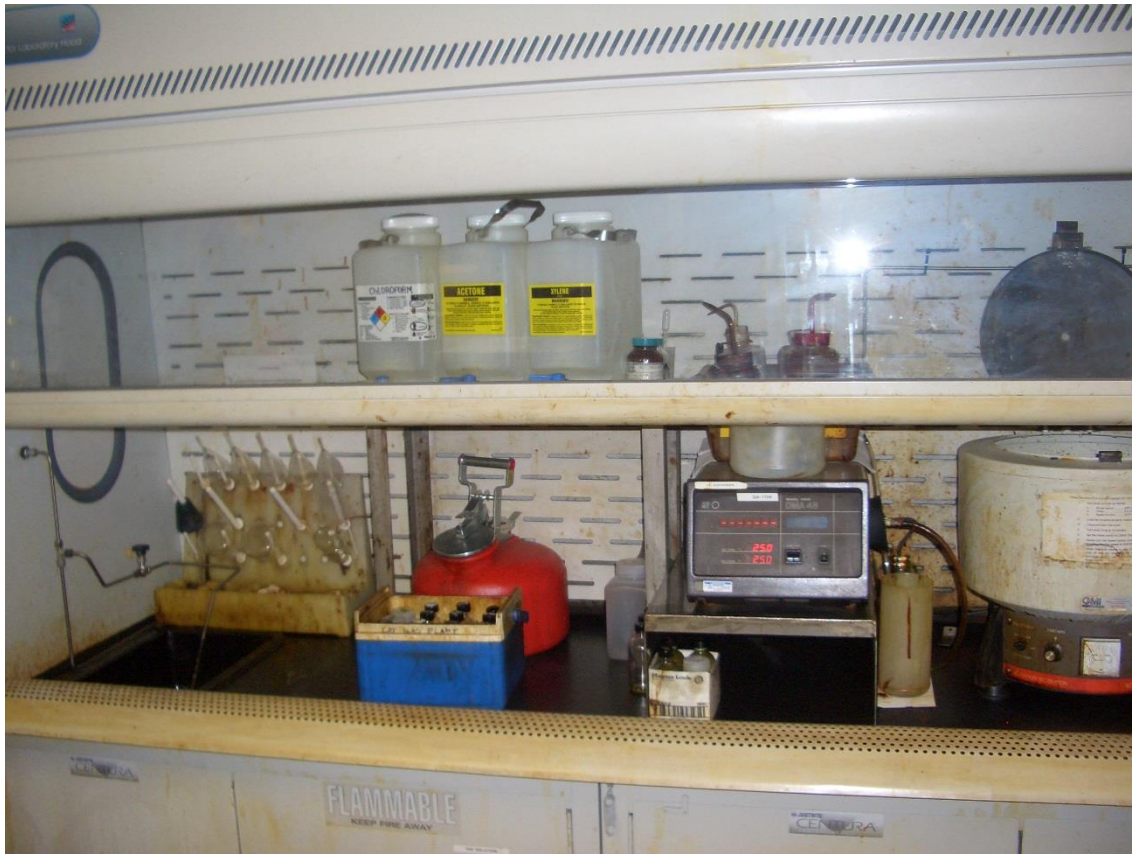
CIMG2545 Fume hood at the Crack Product field laboratory. Note that the red satellite accumulation container was not labeled.

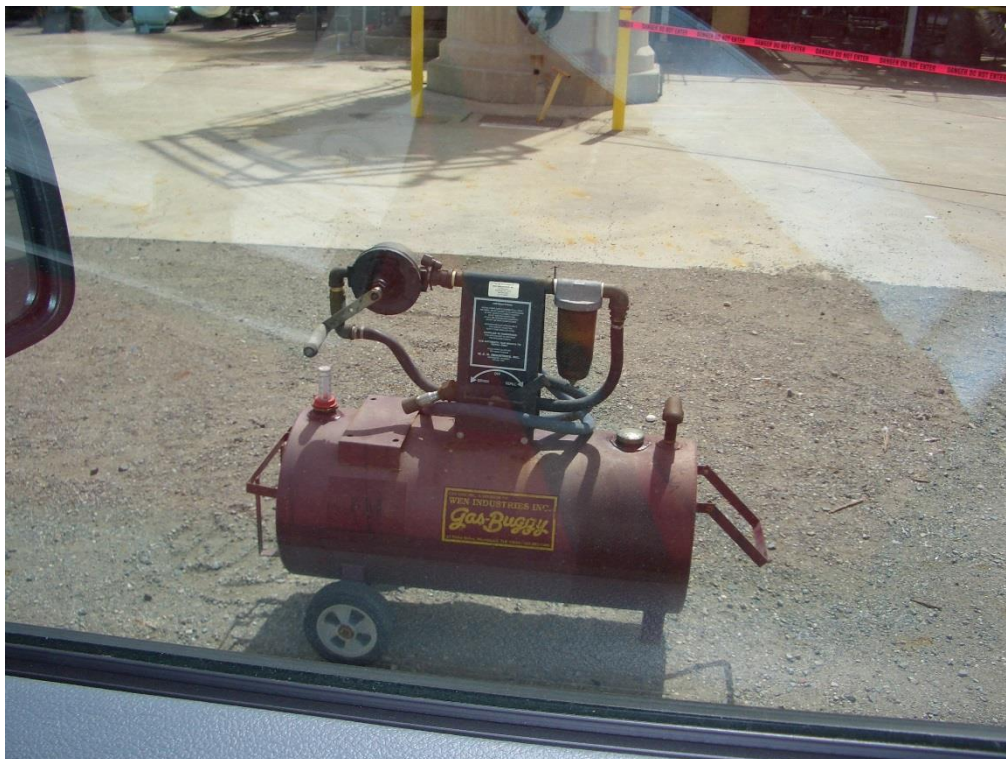
CIMG2546 "R2D2" gas buggies on the process block.

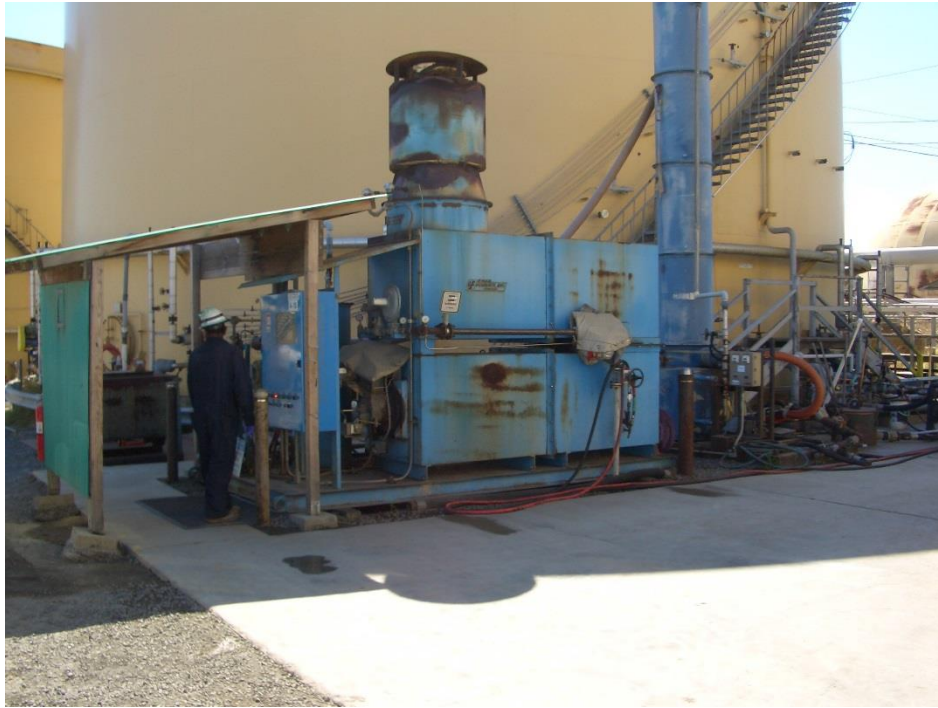
CIMG2487 Recovered Oil Unit, Tank 15096 in the background

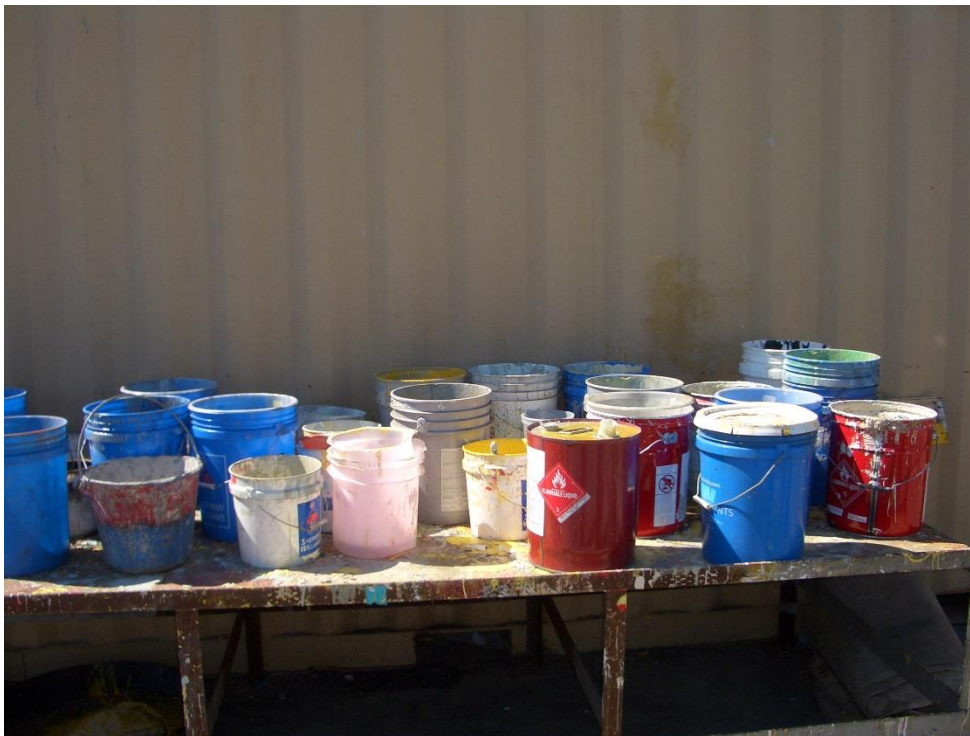
CIMG2515 Sandblast pad/paint area – containers with spent solvent and aqueous based paint wastes were left open to dry.

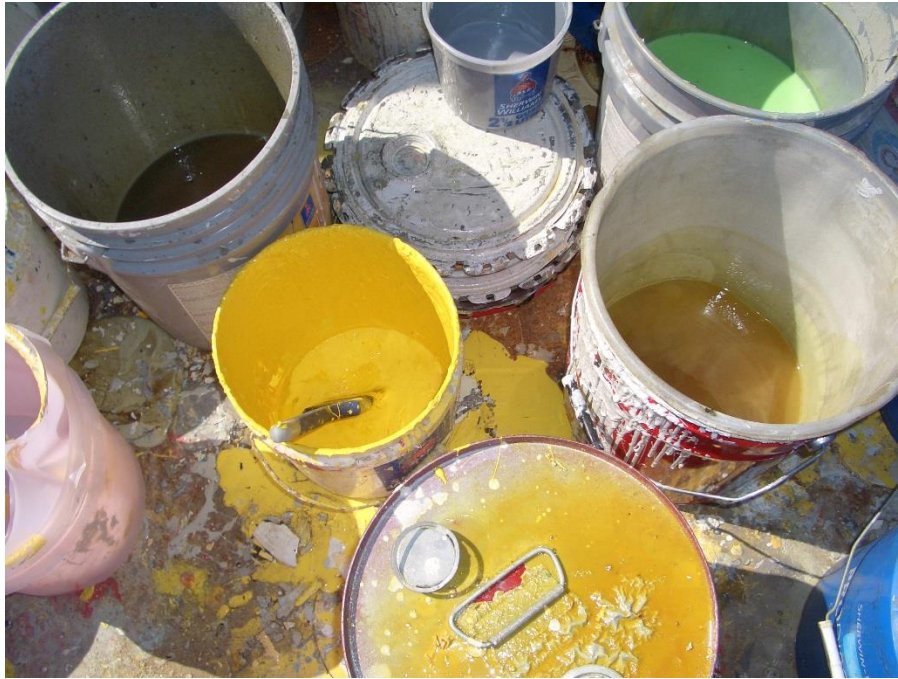
CIMG2516 Top view of the containers in CIMG2515

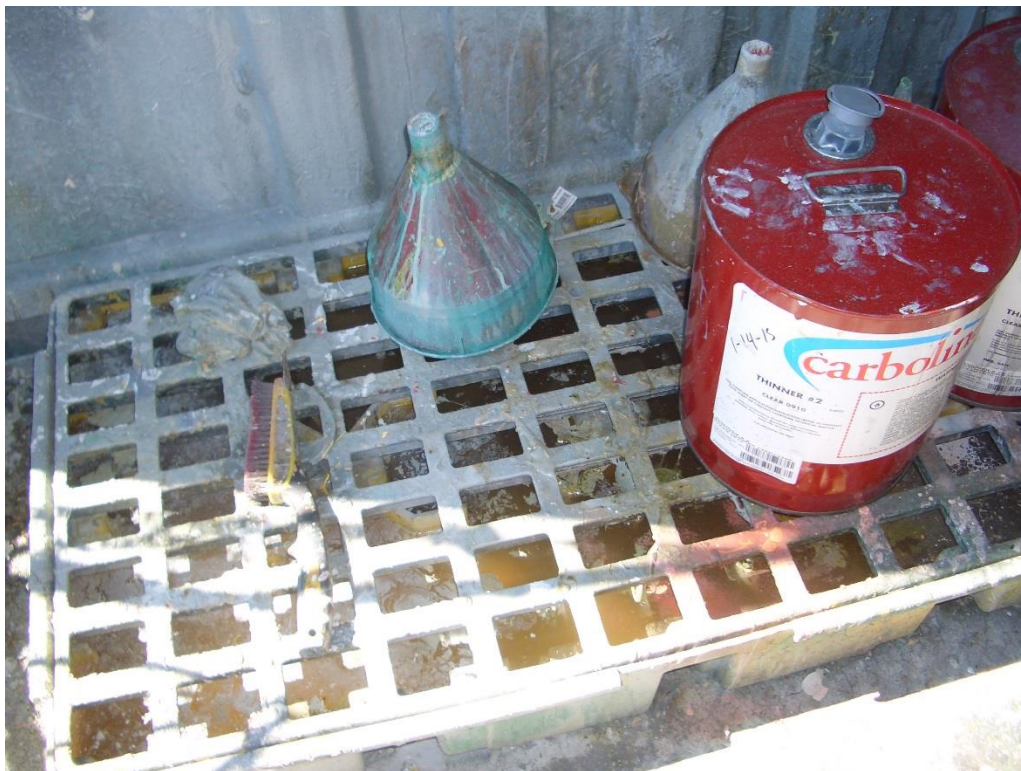
CIMG2518 Secondary containment pad for the paint locker at the Sandblast pad area.

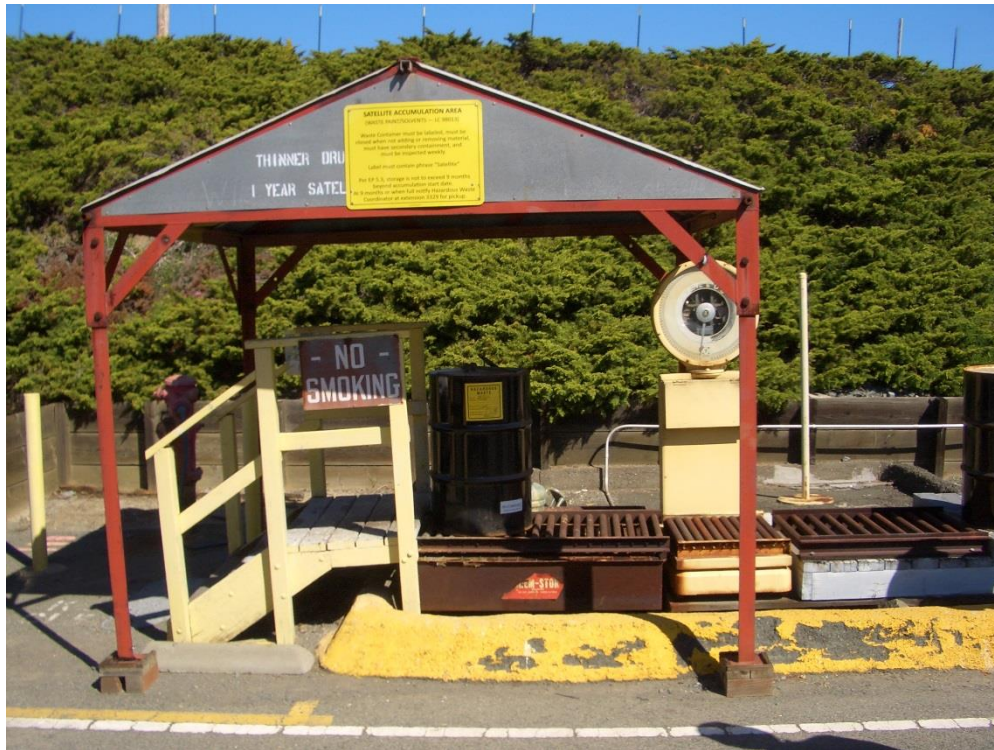
CIMG2512 Hazardous waste satellite collection area at Shell's maintenance/paint shop.

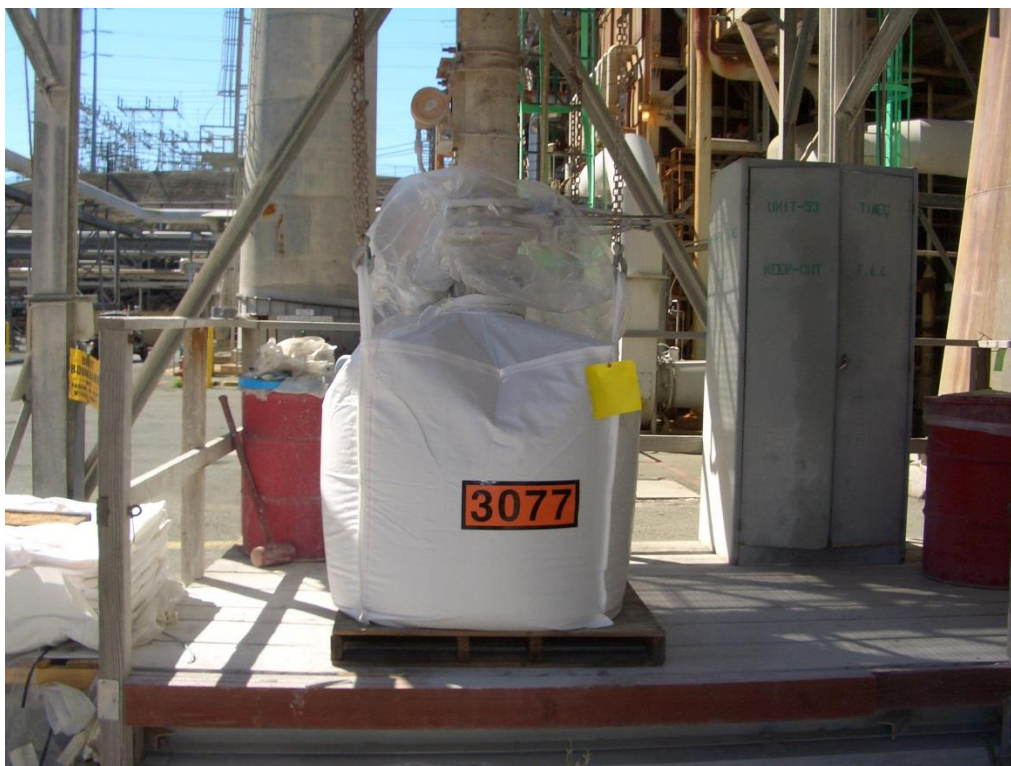
CIMG2491 Super sacks containing K048/D010 fly ash wastes. Note accumulation of fly ash on the wooden structure.

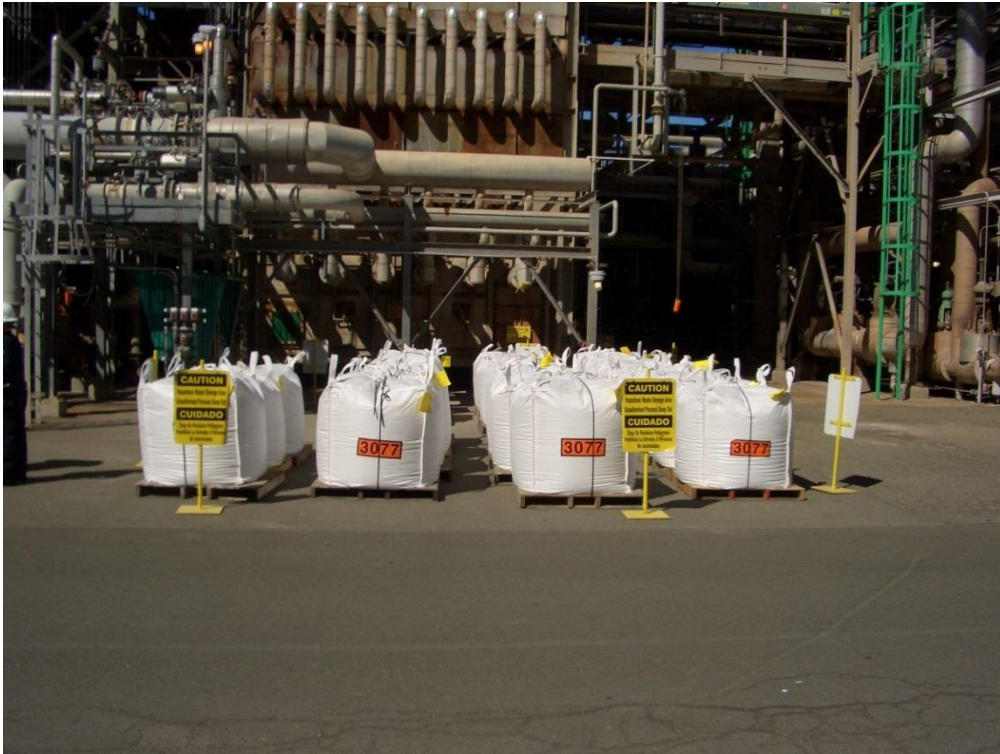
CIMG2492 25 Super sacks (one cubic yard each) of K048/D010 fly ash waste

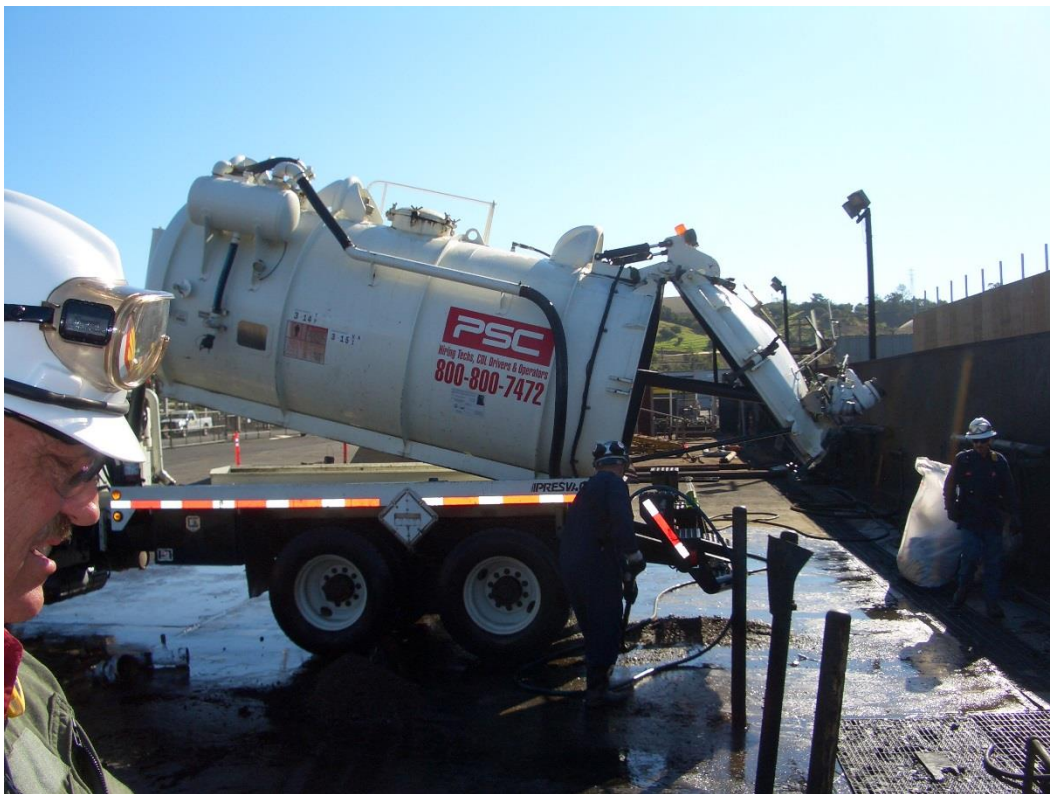
CIMG2493 Heat Exchanger Bundle Cleaning Pad area.

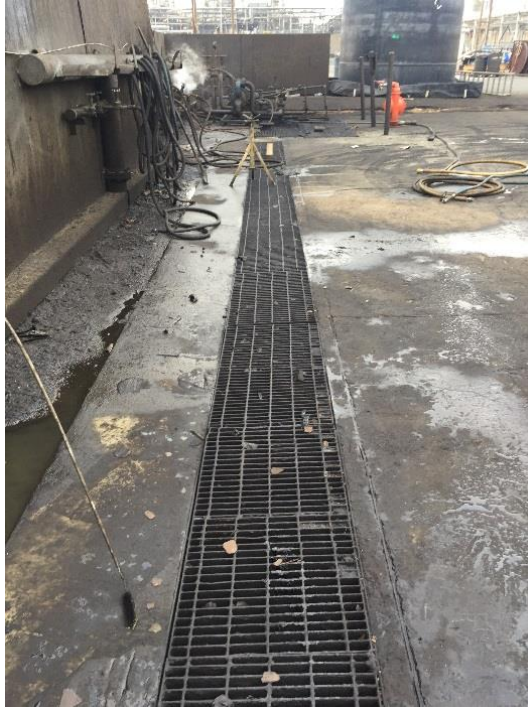
IMG\_1201[1] Heat Exchanger Bundle Cleaning Pad - taken by Contra Costa County Health Services Inspector on 12/18/2015

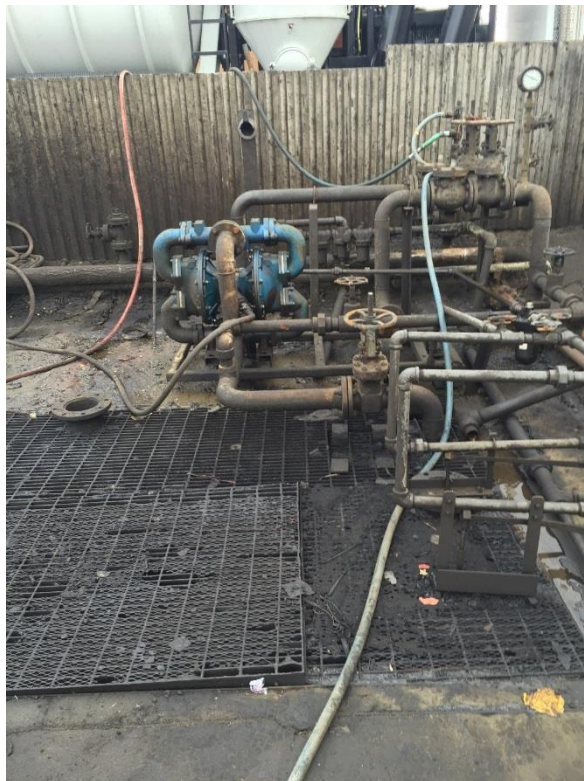
IMG\_1203[1] Heat Exchanger Bundle Cleaning Pad - taken by Contra Costa County Health Services Inspector on 12/18/2015.

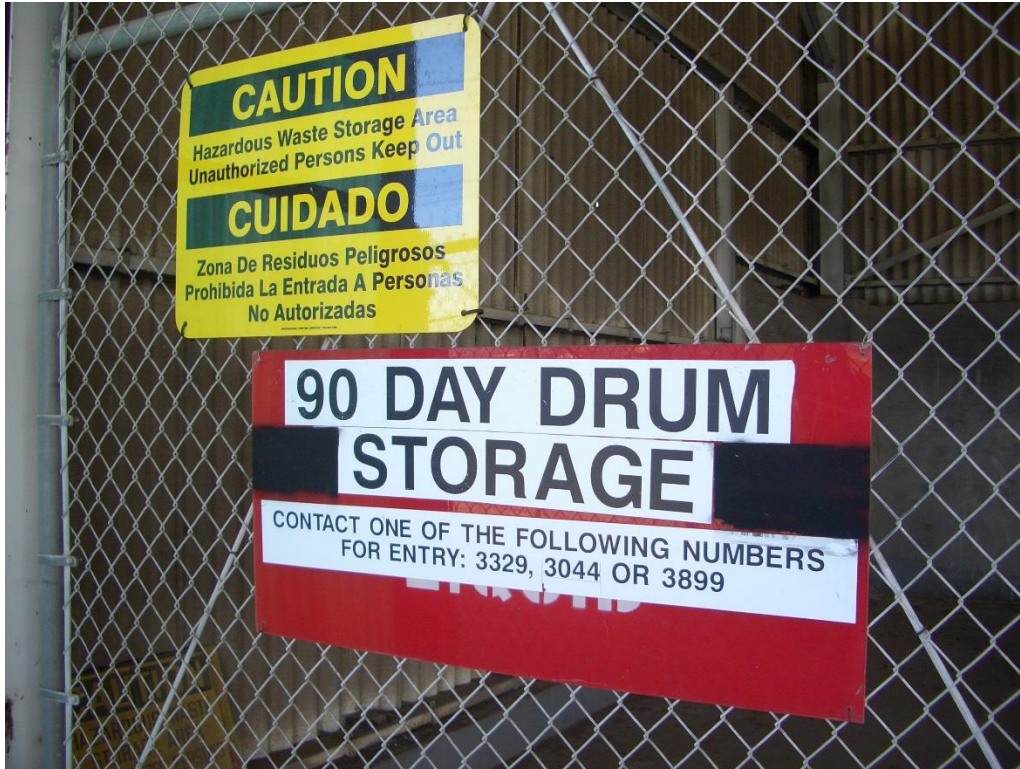
CIMG2391 SMR's 90 Day Drum Storage Area HWAA

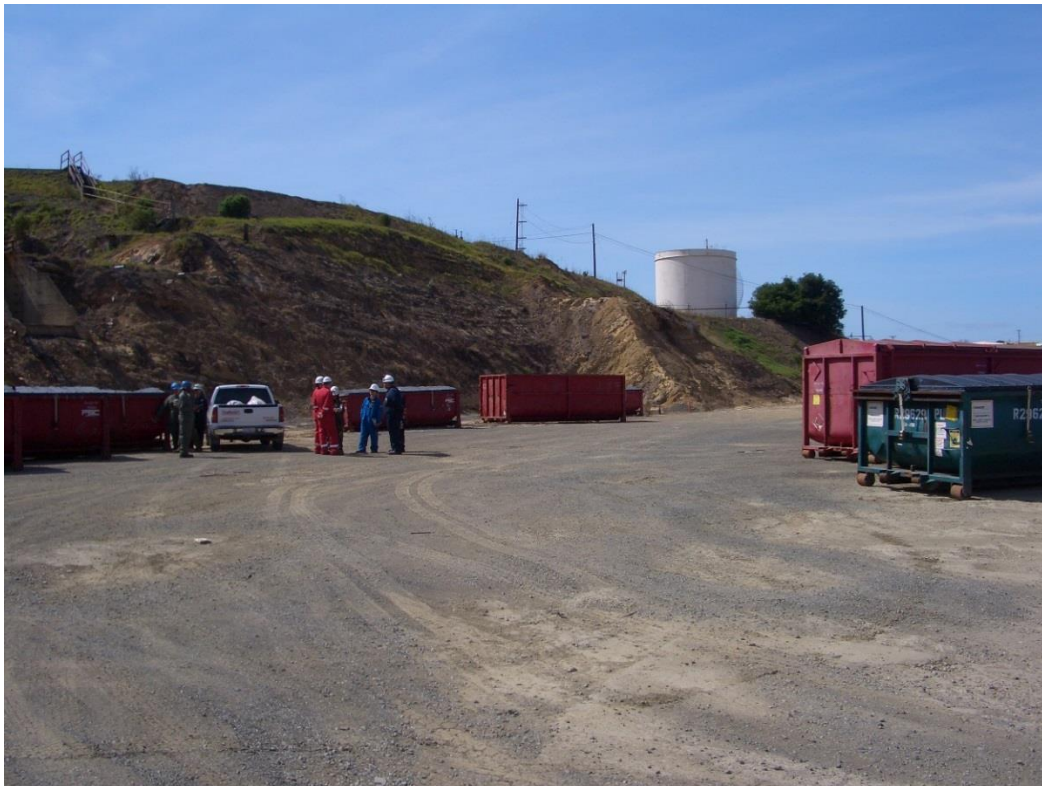
CIMG2387 Containers in SMR's Bin Storage Yard HWAA
